Vernal Pike Connector
From West Vernal Pike to Profile Parkway
Des. No.: 1702957 & 1900406
Monroe County, Indiana

Appendix E

Re: RED FLAG INVESTIGATION
DES 1702957, Local Project
Vernal Pike Connector Road
Monroe County, Indiana

WETLAND DELINEATION
Vernal Pike Connector
From West Vernal Pike to Profile Parkway
Des. No.: 1702957 and 1900406
Monroe County, Indiana

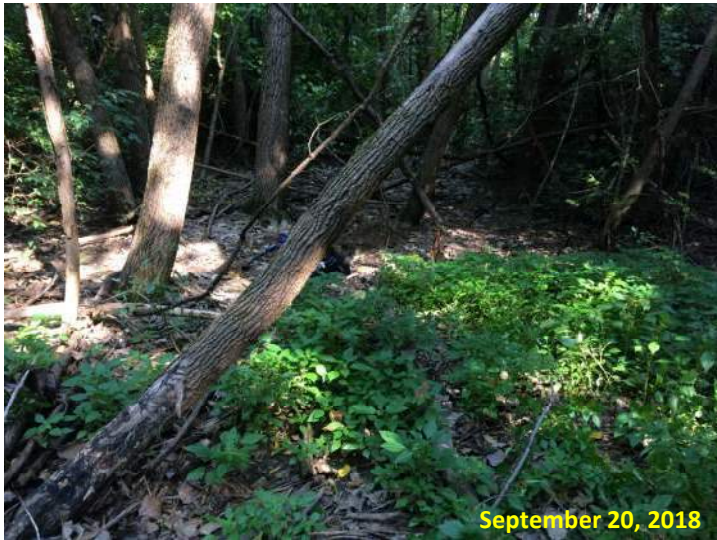
Photo 13: View of Wetland A looking north

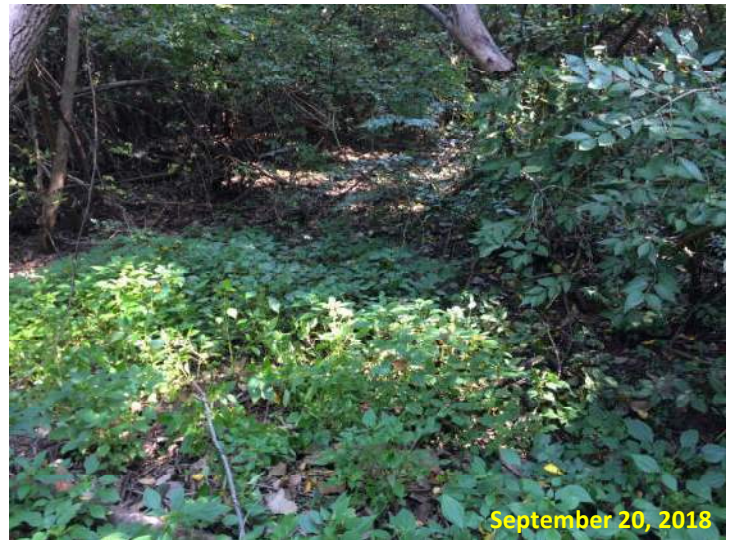
Photo 14: View of Wetland A looking south

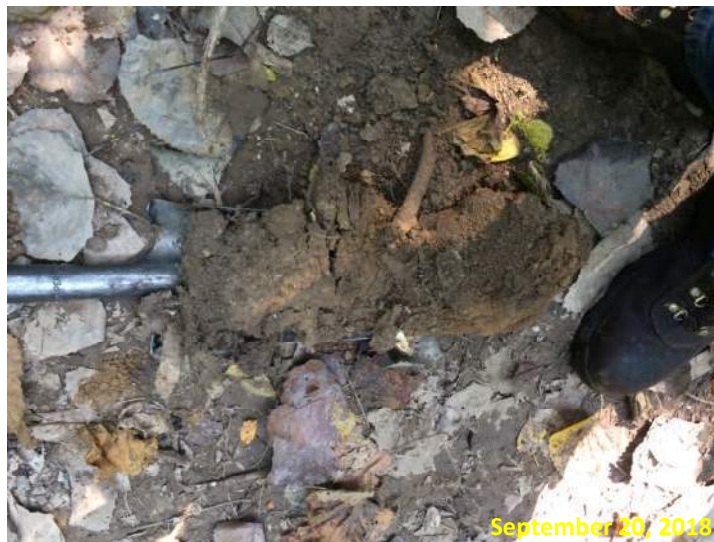
Photo 15: View of Wetland A soil pit (SP-1)

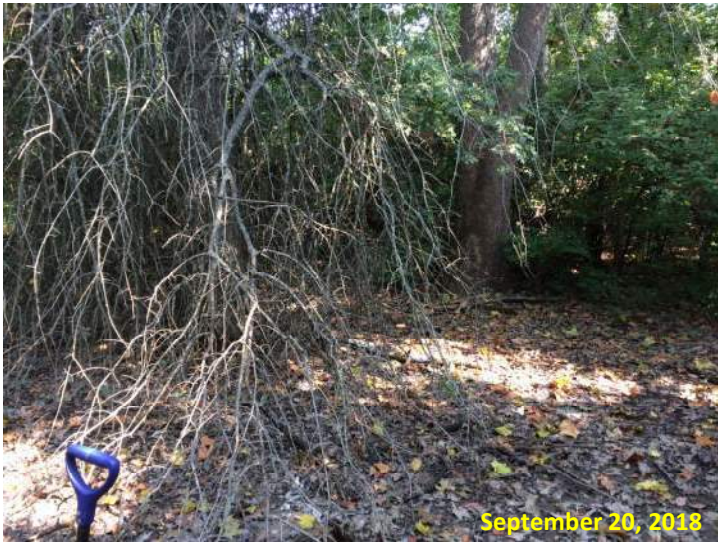
Photo 16: View of Wetland B looking north

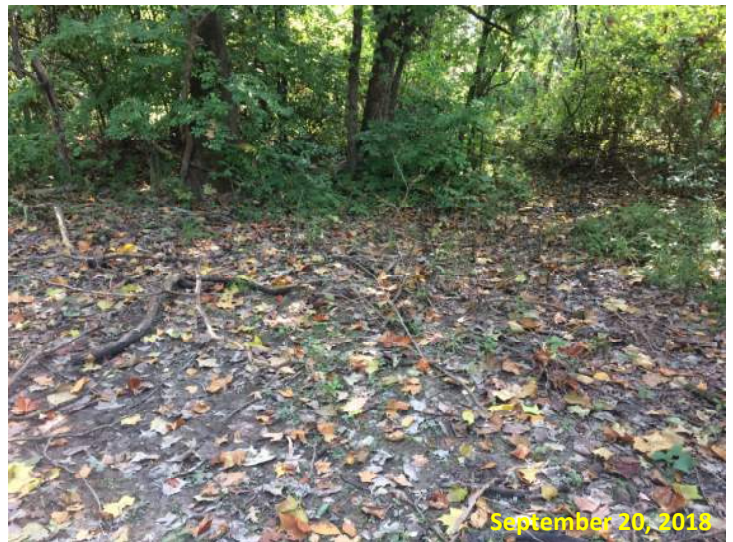
Photo 17: View of Wetland B looking south

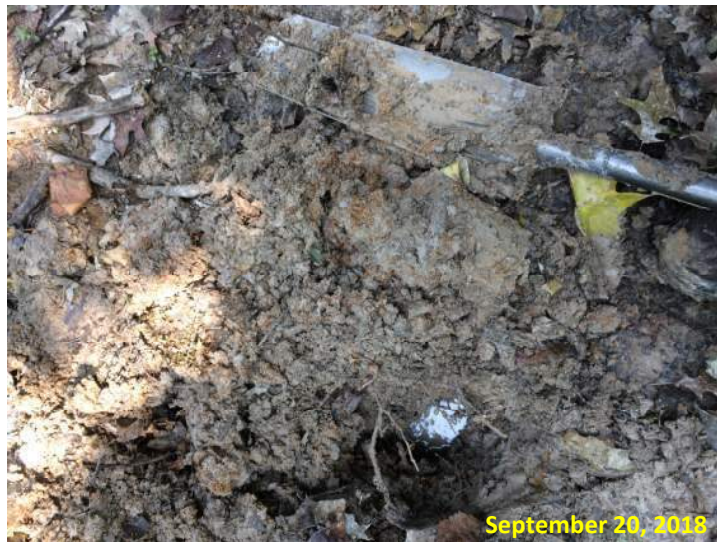
Photo 18: View of Wetland B test pit (SP-3)

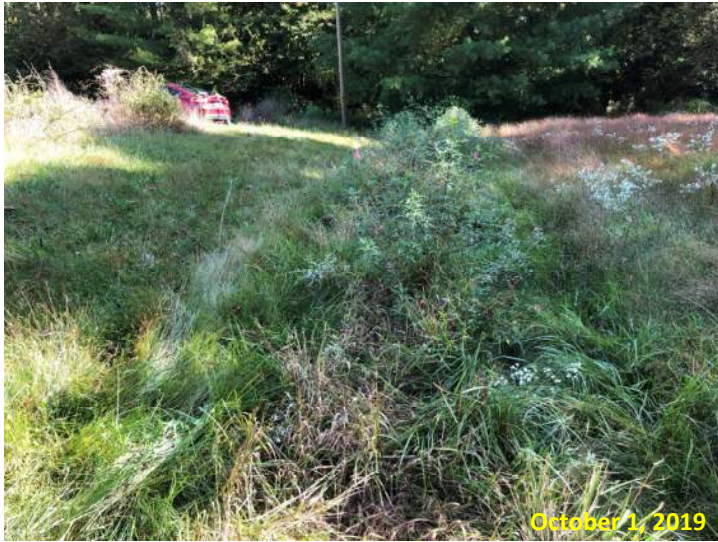
Photo 19: View of Wetland C looking east

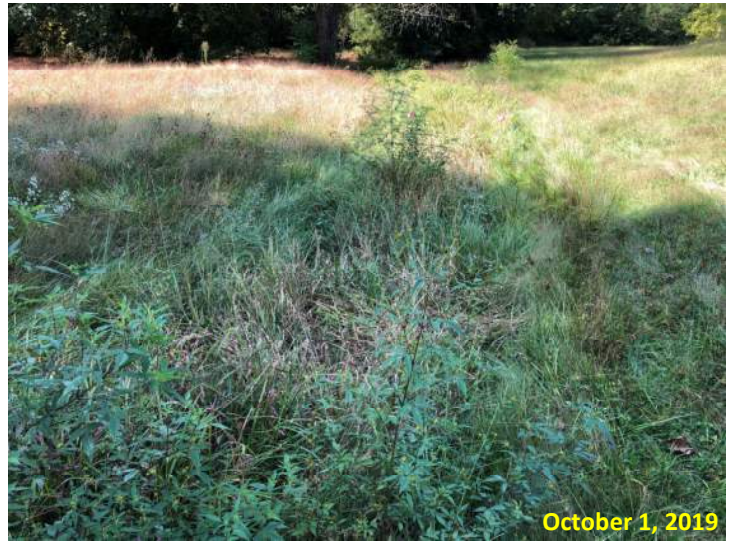
Photo 20: View of Wetland C looking west

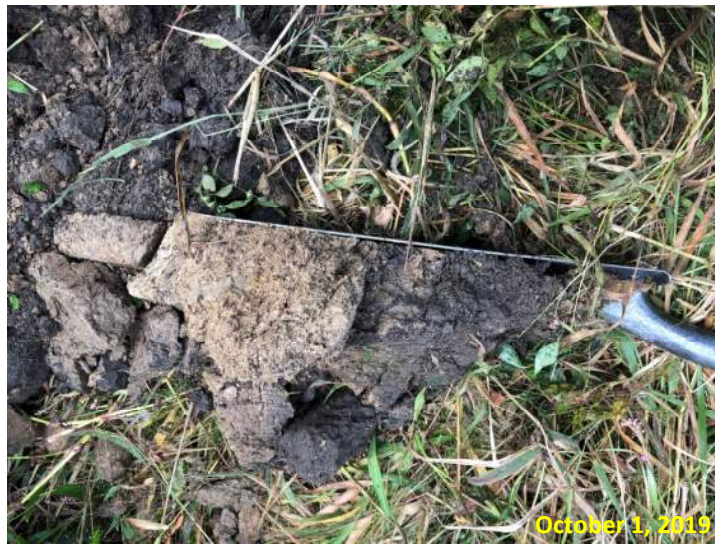
Photo 21: View of Wetland C test pit (SP-5)

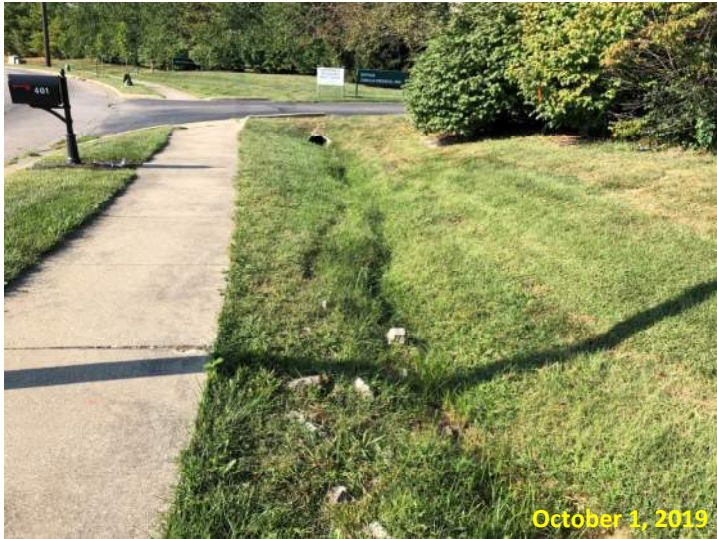
Photo 22: View of Roadside Ditch 1 looking southwest along N. Gates Drive

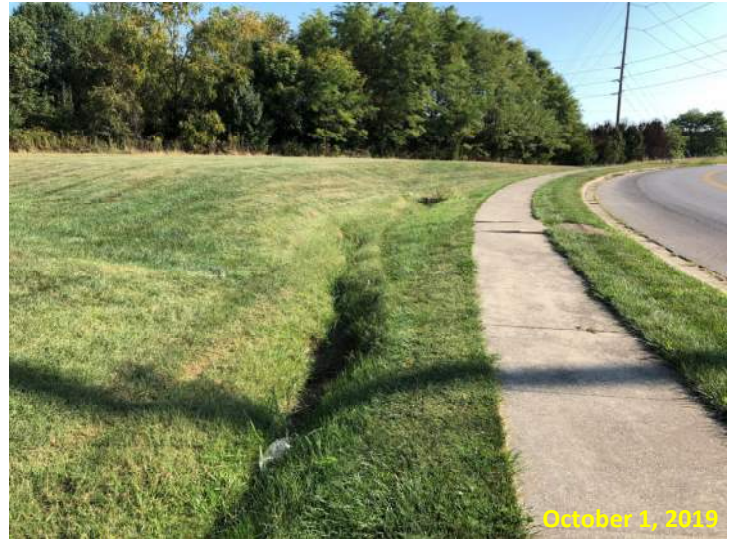
Photo 23: View of Roadside Ditch 1 looking northeast along N. Gates Drive
